Limited Phase II Subsurface Investigation

LIMITED PHASE II SUBSURFACE INVESTIGATION

Carlos Street at Sierra Street
Moss Beach, San Mateo County, California 94038

AEI Project No. 350428

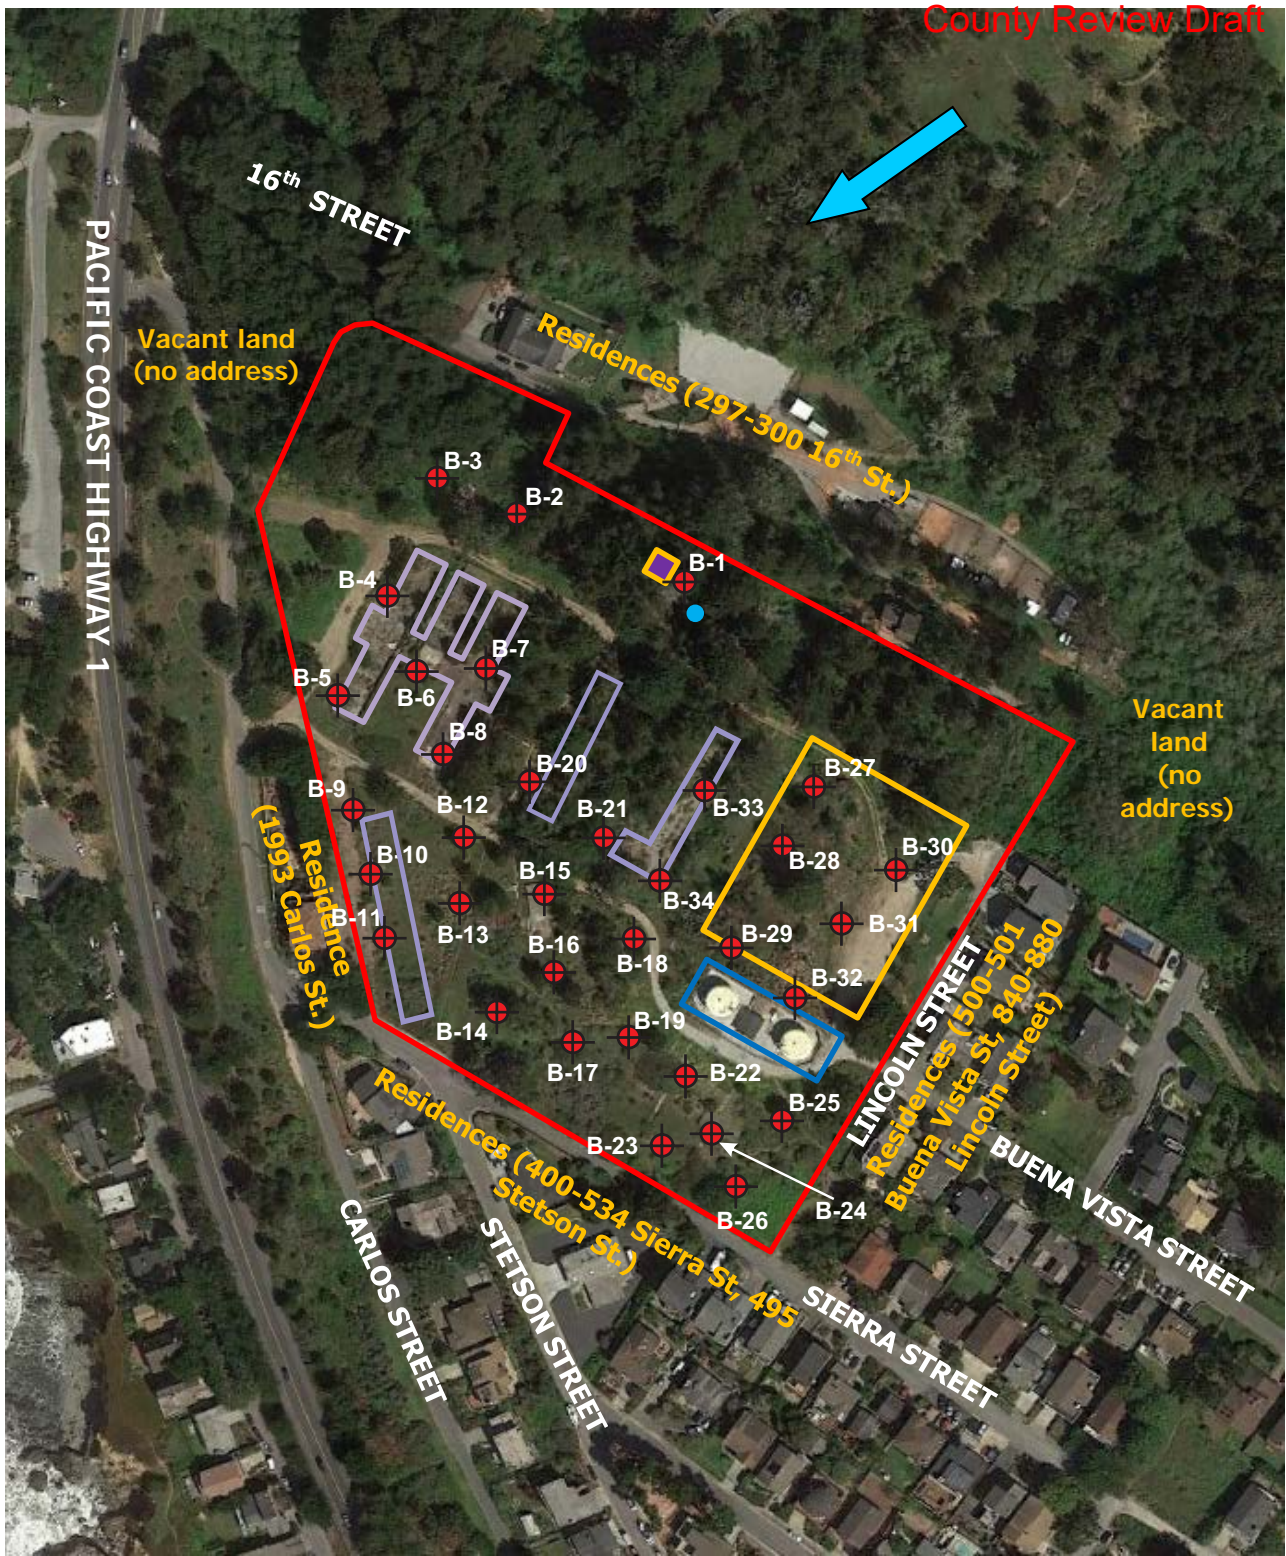
The drilling program for this investigation was conducted on December 22 and 23, 2015. Thirty-three exploratory borings (B-1 and B-3 through B-34) were advanced to depths between 2.0 and 9.5 feet bgs. Of these total borings, twenty-seven (27) borings were advanced to the 2.0-foot depth for the collection of soil samples at the 0.0- and 1.5-foot depths. These locations included Boring B-1, which was advanced around the former incinerator area, and Borings B-4 through B-11, B-14, B-16, and B-18 through B-34, which were advanced to the 2.0-foot depth around former concrete foundation areas and "drill field" area. The other five (5) borings were advanced to depths between 5.5 and 9.5 feet bgs with soil samples for laboratory analyses obtained at depths between 2.0 and 7.0 feet bgs. These locations included Boring B-3, which was advanced along the west side of the concrete foundation for the former boiler room, and Borings B-12, B-13, B-15, and B-17, which were advanced to the 9.5-foot depth around the former locations of concrete pads suspected of using accelerants during firefighter training. Four attempts were made to advance Boring B-2; however, this location was abandoned due to drilling refusal encountered just below the ground surface at each attempted location. The locations of these borings are shown on Figure 3.

During the site reconnaissance, it is believed that the location of the "upper well" was found. It is located upslope and to the east of Boring B-1, as shown on Figure 3. The surface completion for this well consists of a rectangular-shaped concrete pad which surrounds rusted, welded steel cover. The lower well was not located during the site reconnaissance. It is unknown if either of these wells were properly abandoned (i.e., backfilled with a new cement grout using tremie methods) in accordance with local regulations.

On the basis of the information, presented above, AEI recommends that a limited soil sampling program be performed to further assess the horizontal extent of lead-impacted surface soils around the two identified locations. AEI also recommends that the steel cover for the "upper well" be removed an experienced water well driller under subcontract to AEI to measure the well depth, as well as whether the well has been properly abandoned in accordance with County regulations.
