# BMP Inspection - Weekly

Site Name: Highlands Builder: Nexgen Builders City: San Mateo Zip Code: 94401  
Job Site Contact: Bob Pellegrine Company: Cervelliere Limited Job Site Phone: 650-445-0914

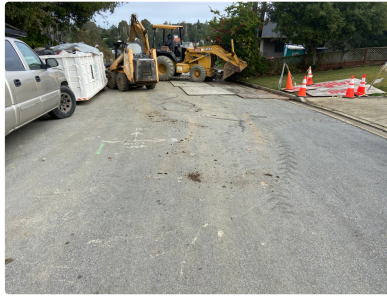
The street and Lot 9, & 10 needs sweeping

Deficiency	Action	Notes
Perimeter controls are established and effective at controlling erosion and sediment discharges from the site	Repair/ Replace	To the right on Lot 11 the silt fence has broken and needs repairing/replacing.
Inspect all immediate access roads daily	Sweeping	The street and Lot 9, & 10 needs sweeping
